Note on QC and reprocessing of Exp319 FMI imaging

August 23, 2010

Yoshinori Sanada, CDEX LSS /JAMSTEC

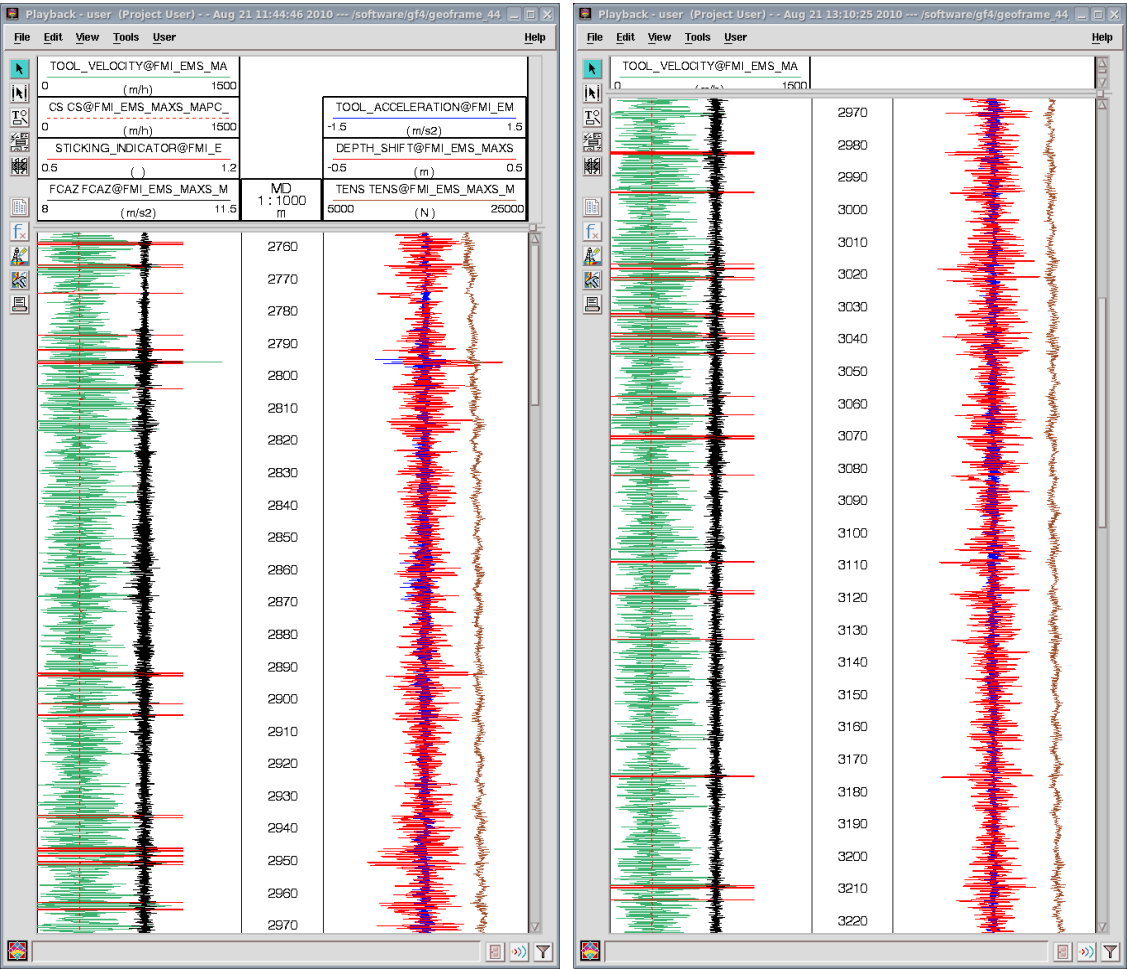
Many “STICKING_INDICATOR” are flagged in sticking intervals (below 3375mBRT), and depth shift are recalculated in Figure 4.

Figure 4 (a) left and (b) right: tool motion, STICKING_INDICATOR, depth shift to be applied.

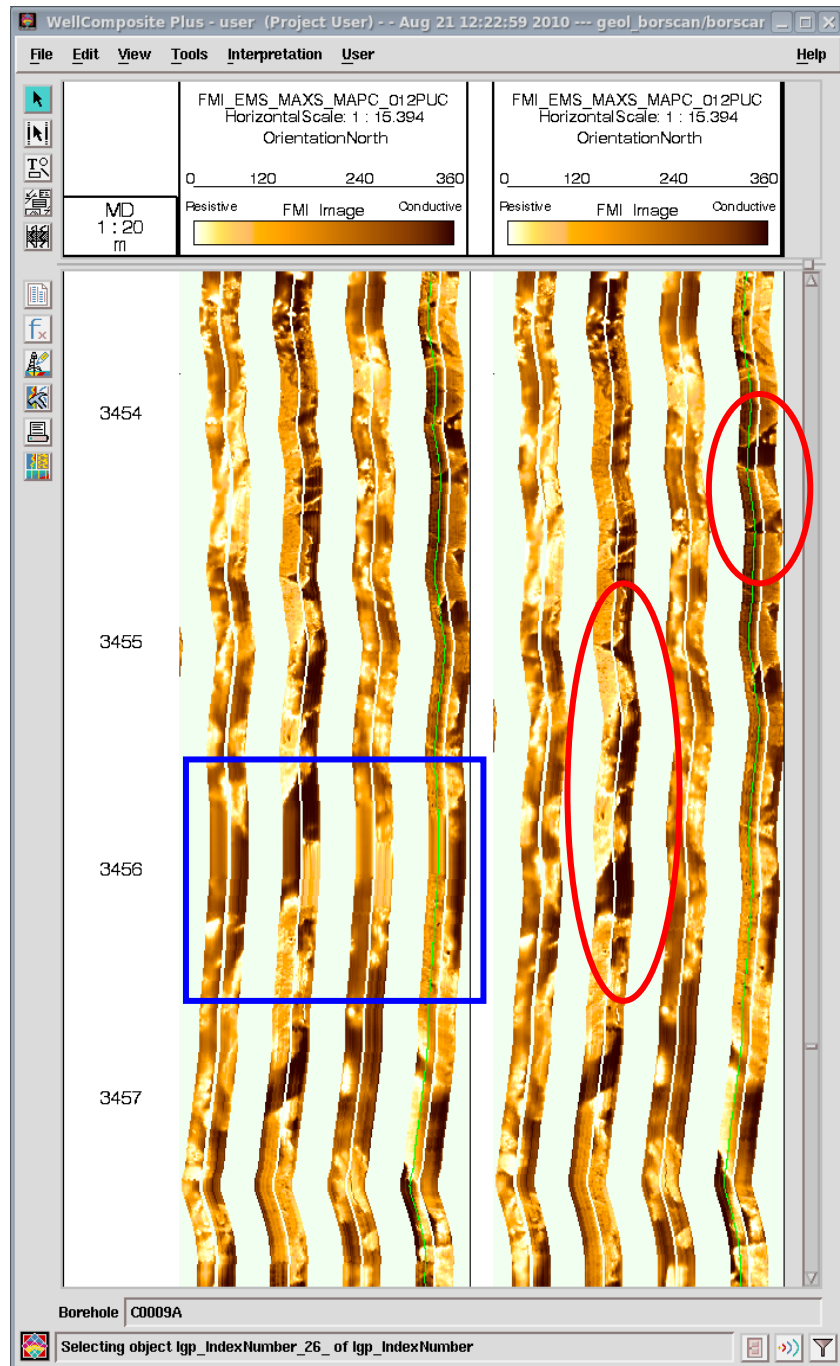
The stretching by tool slip are shown in 3455.5-346.5mBRT (highlighted with blue

rectangular) in the left of Figure 6 and 7. The position and distortion are corrected by applying with “Stick Detection” in red circles in the right of Figure 6 and 7.

Figure 6: Left is the images without “Stick Detection”. Right is the image with “Stick Detection” in 3454-3457mBRT.

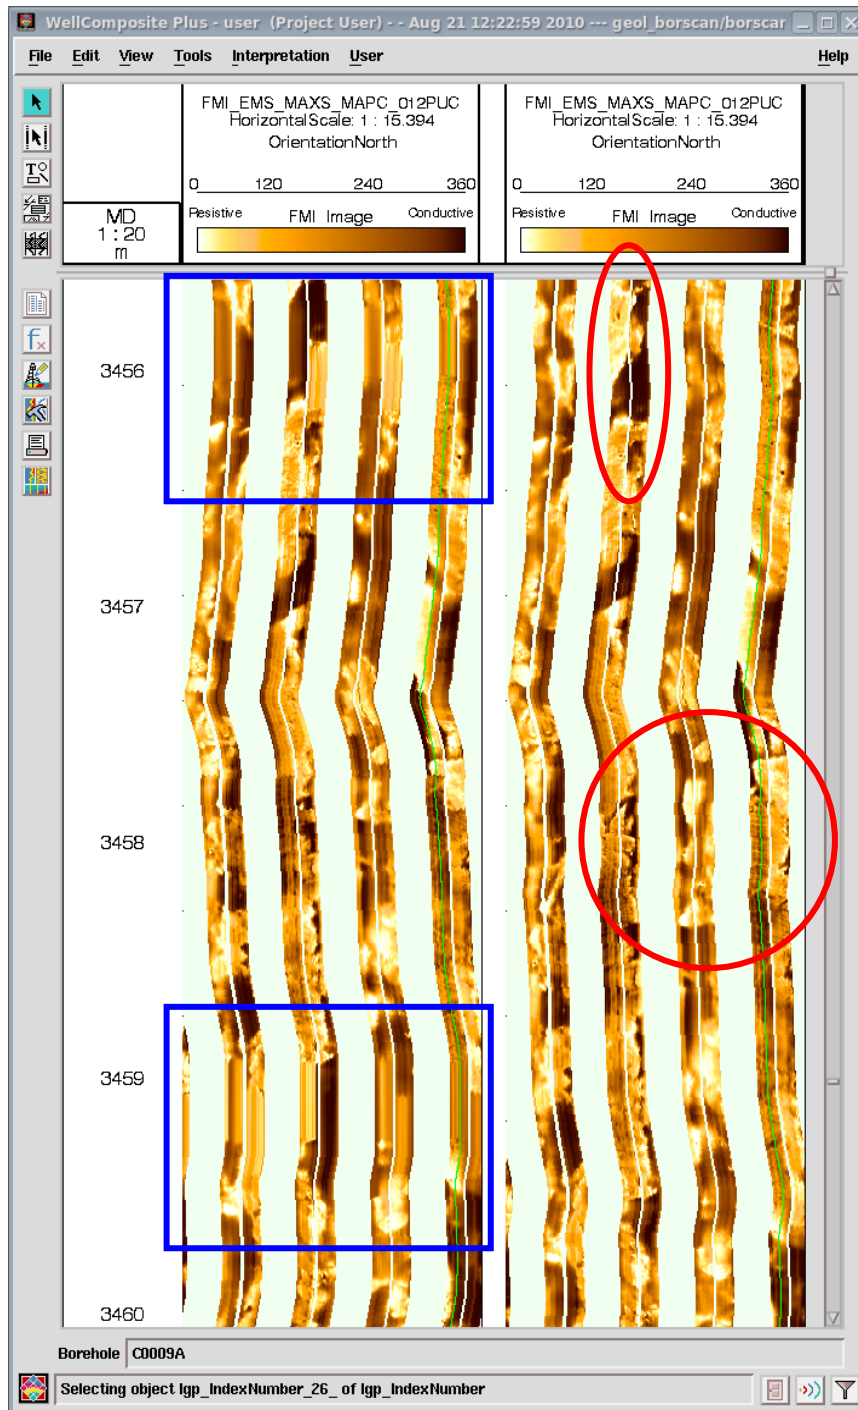
Figure 7: Left is the images without “Stick Detection”. Right is the image with “Stick Detection” in 3456-3460mBRT.
